EXPERT REPORT
OF
DAVID J. ERICKSON

Community Association for Restoration of the Environment, Inc.

Cow Palace, LLC

(E.D. Wash. No. CV-13-3016-TOR)

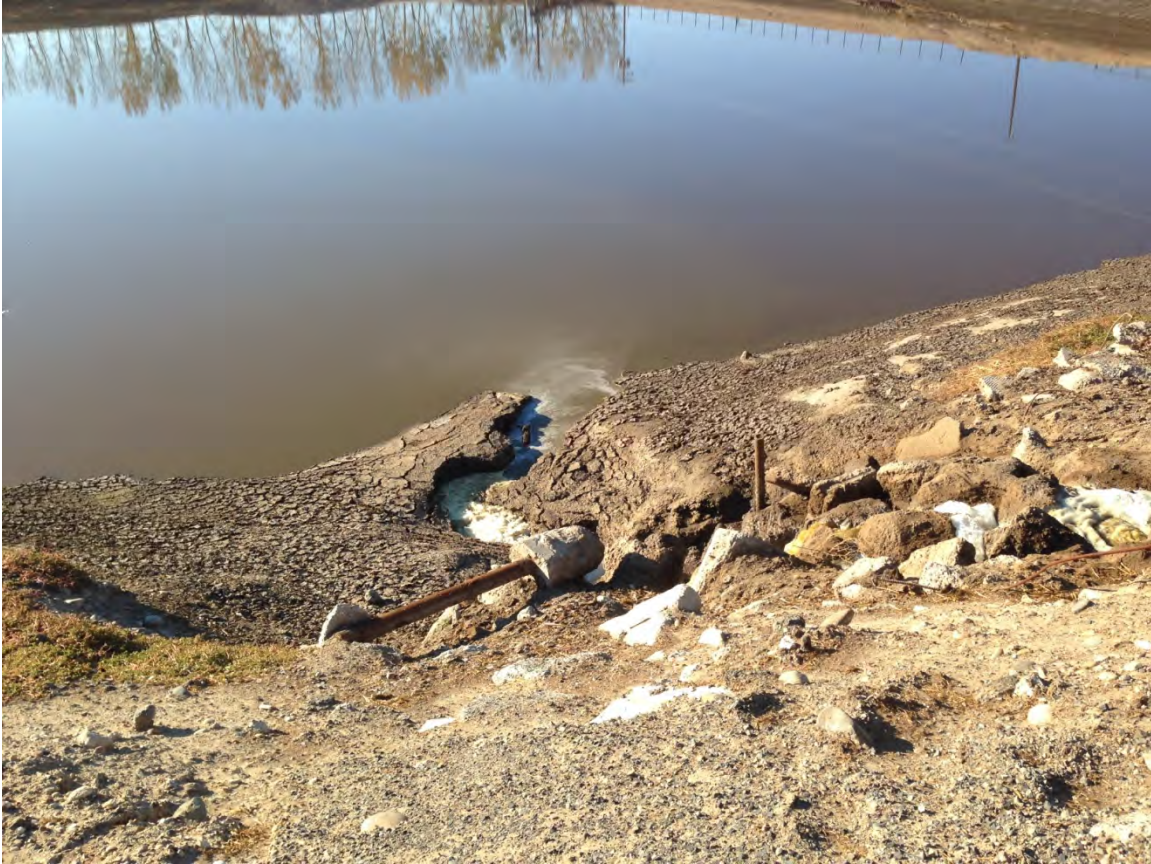
Photo: View to southwest of Lagoon 1. Dried, cracked, and eroded manure seal is visible in foreground.

51. Visible in the photo is the desiccation of the manure seal and the erosion of the manure down to native soil wherever water is discharged into the lagoons.

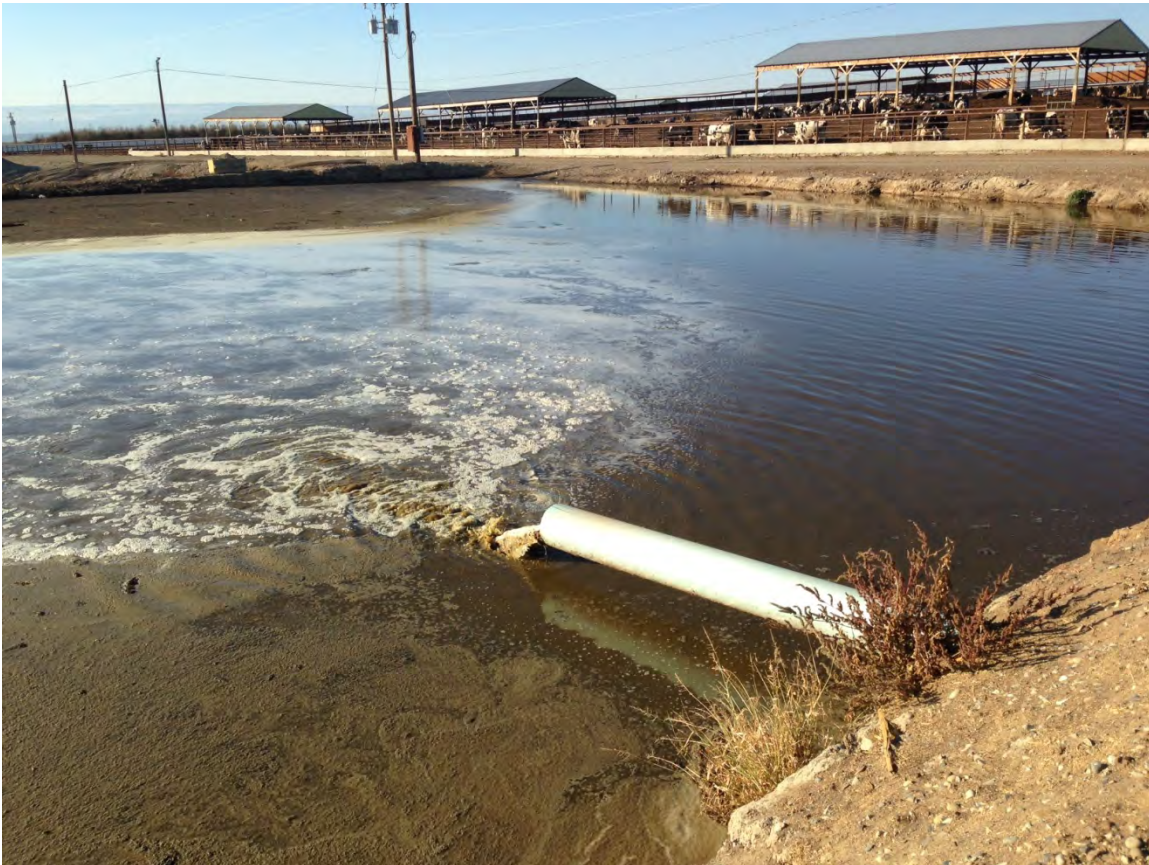
Photo: View to southwest of west Settling Basin. Waste being discharged from collection sump is visible in foreground.

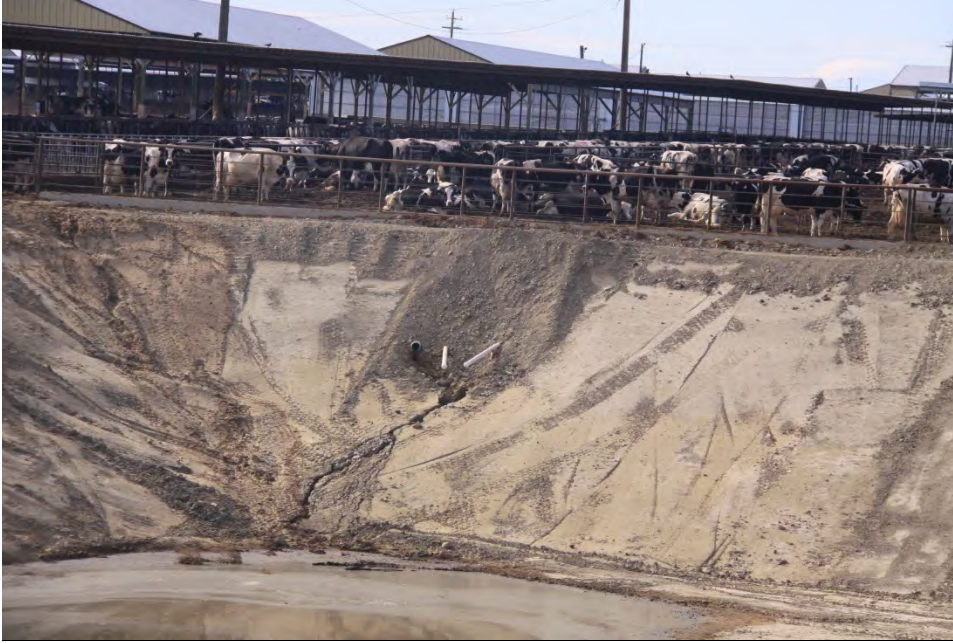
Photo. View of NW Catchment Basin during October site visit. New liner with significant erosion from infall pipes is shown

92. The photos above represent the condition of the Catch Basin NW as it was at the time of Plaintiffs' October 2013 inspection. As is evident from the photographs, Cow Palace had recently completed re-sloping the sides and compacting the soil liner.

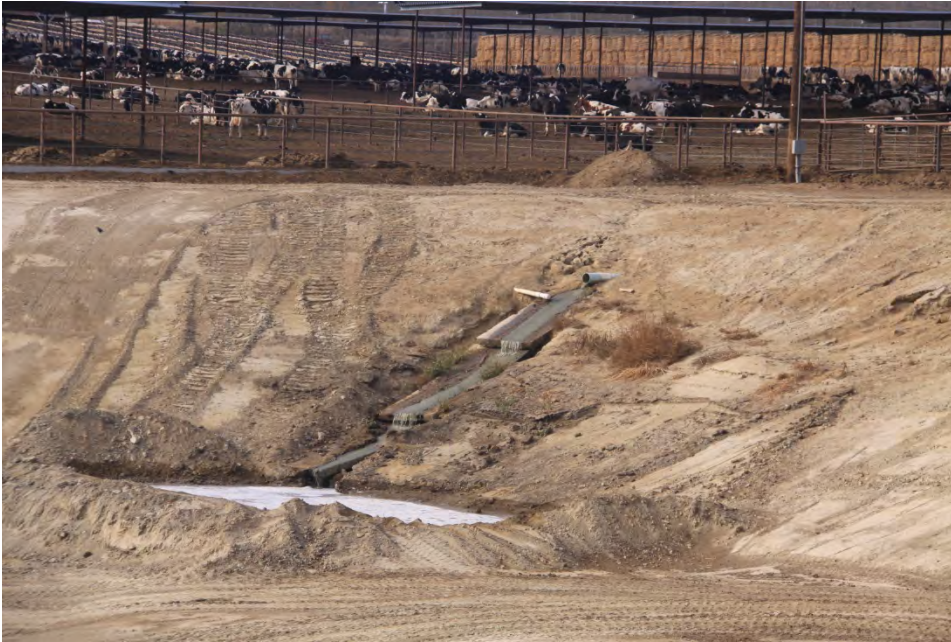
Photo. View of NW Catchment Basin. Outfall from calf pens with liquid infiltrating is shown.

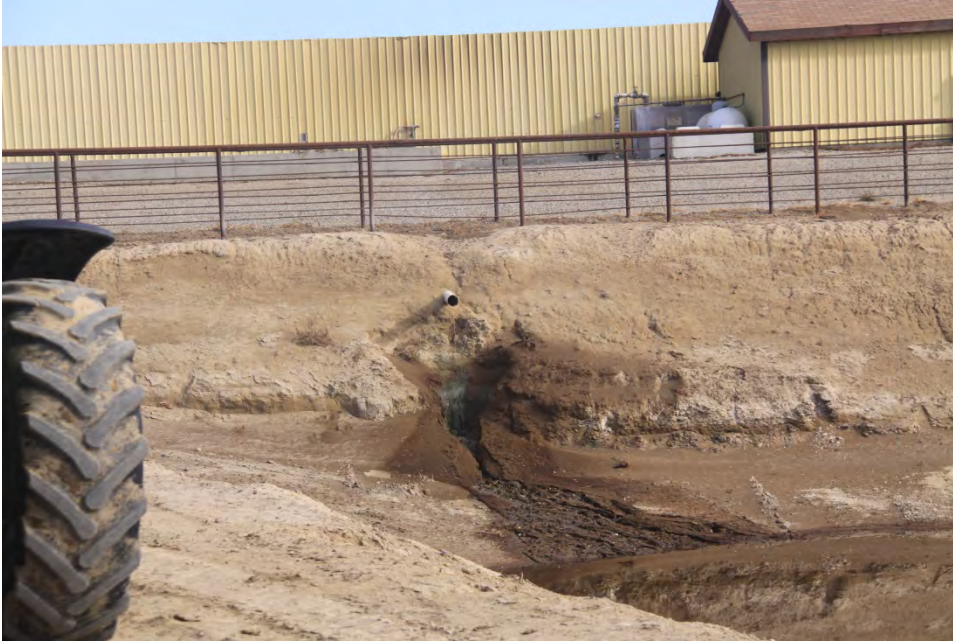
Photo. View of NE Catchment Basin. Note erosion from inflow and lack of manure seal.

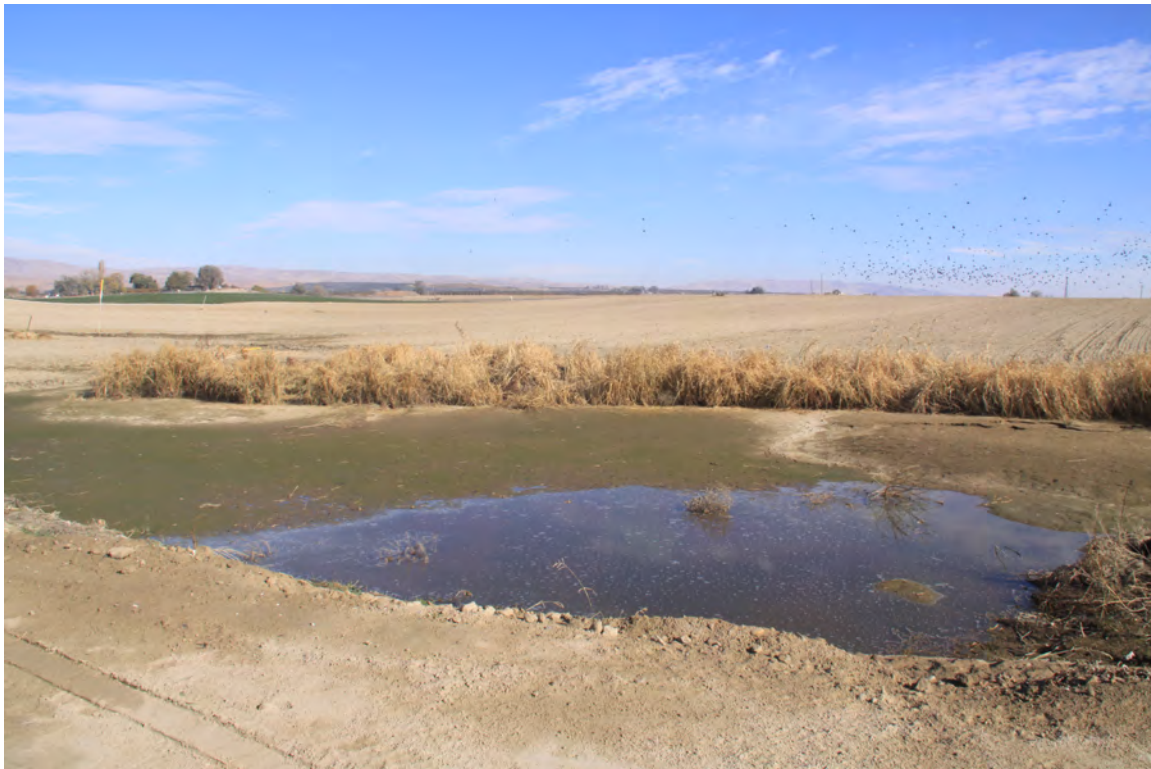
Photo. Tailwater pond adjacent to Liberty

105. There is no question that the tailwater recovery ponds discharge manure-contaminated water into the ground. The concentration of the

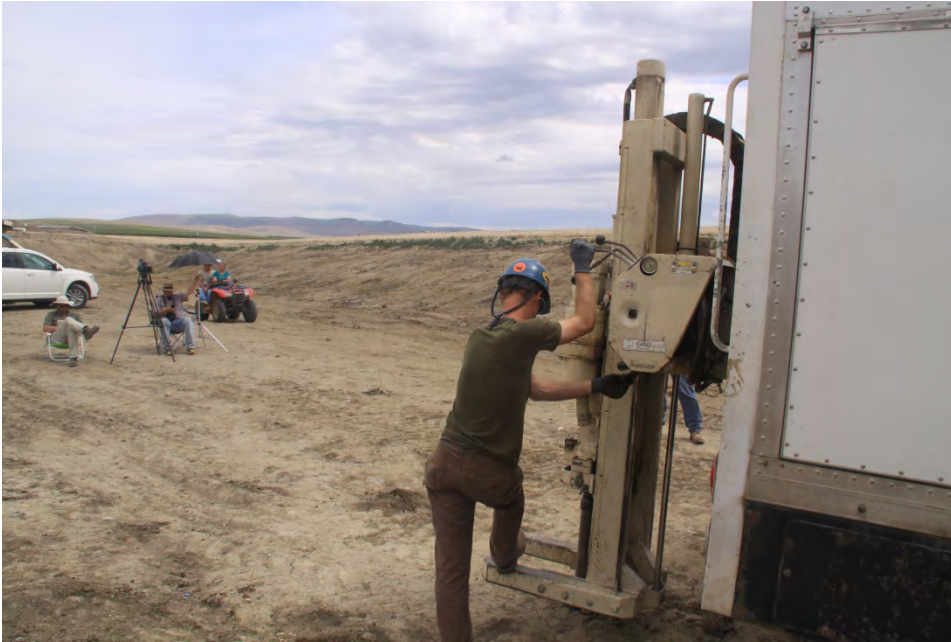
Photo. Collecting Geoprobe samples in the Bottom of Haak Lagoon

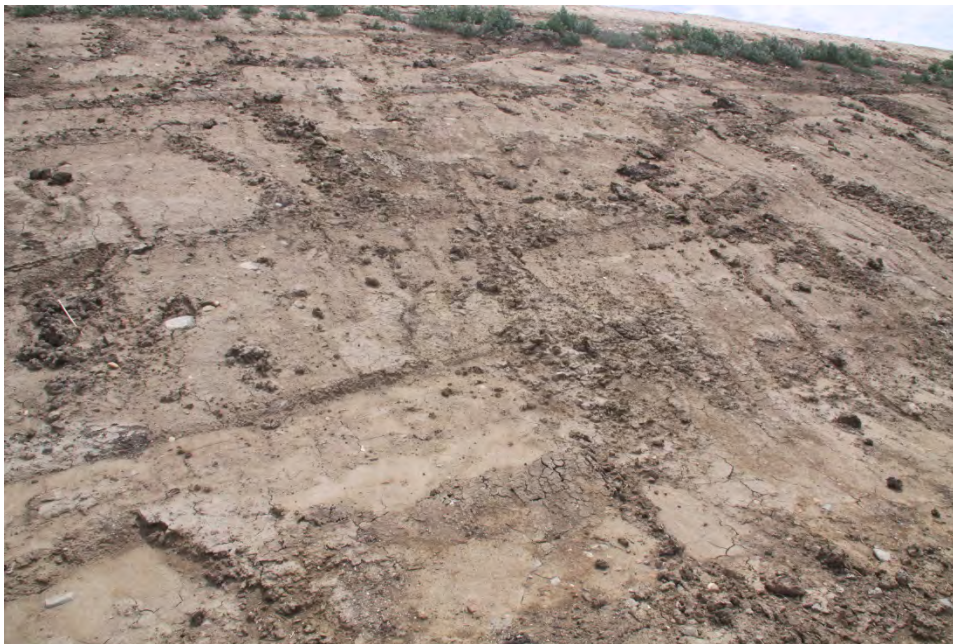
Photo: Side of Haak Lagoon with manure cake and native soil exposed. Note gravel and cobbles.

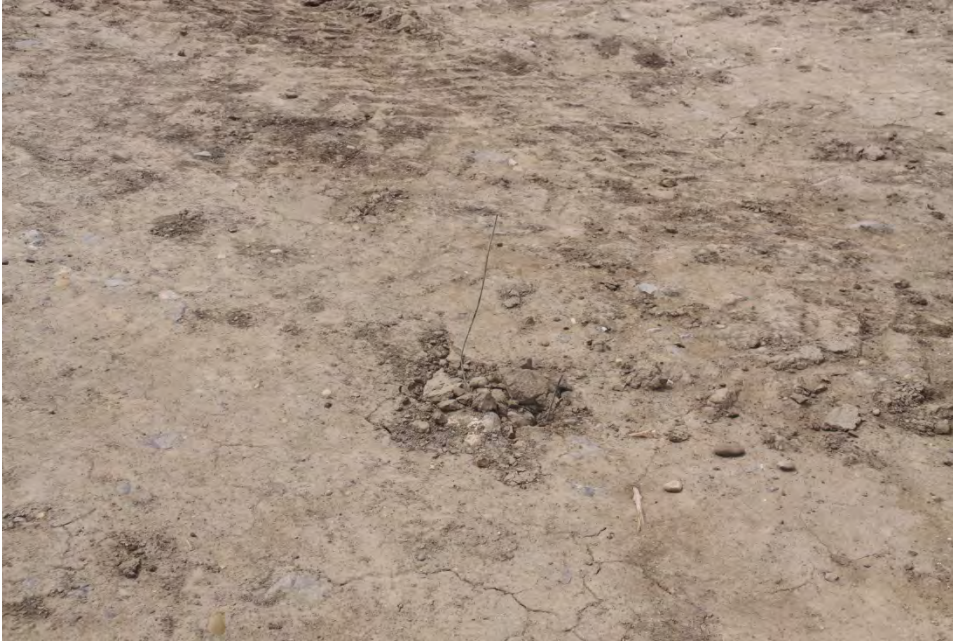
Photo. Bottom of Haak lagoon with native soil and wire.

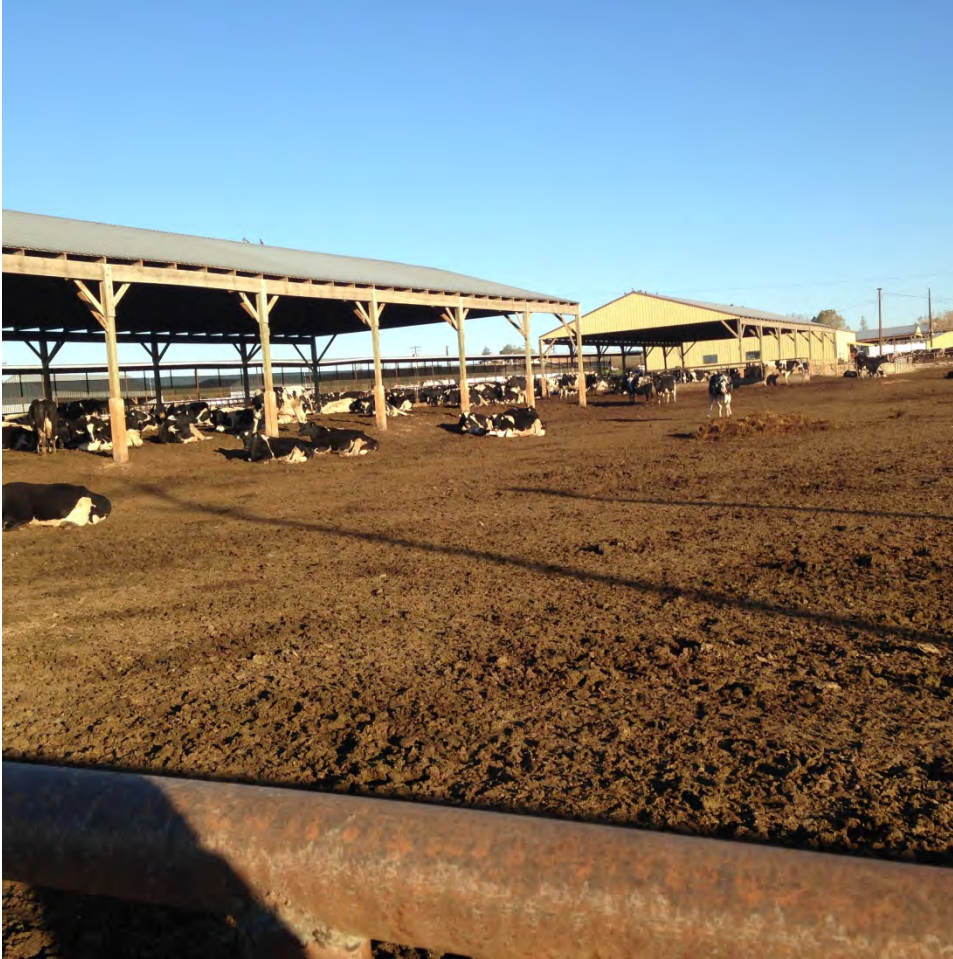
Photo. View to north-northwest of Cow Palace holding pen. Milking parlor visible in background.

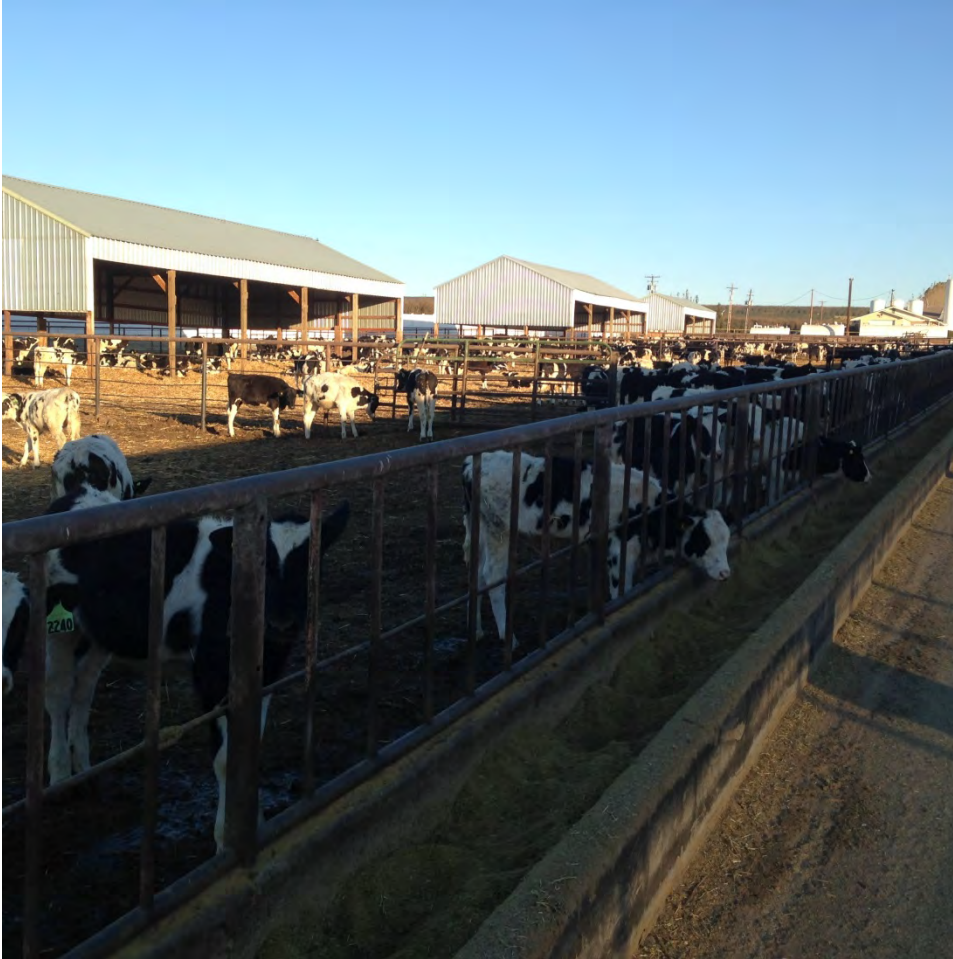
Photo. Note pooled liquid at bottom left.

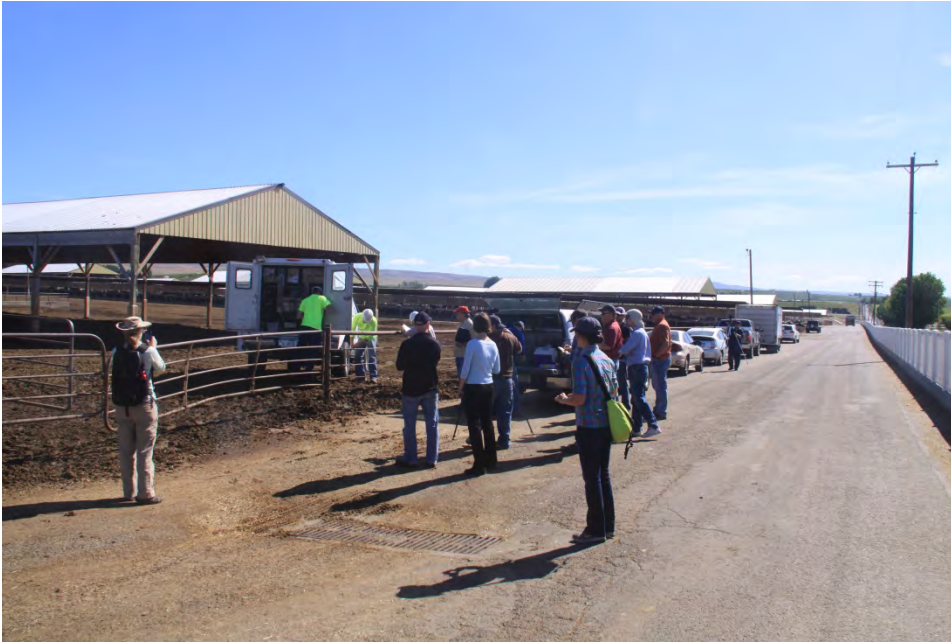
Photo: View of Cow Palace holding pen during May 2014 inspection. Note saturated manure and soil.

121. I understand from the depositions of Cow Palace's personnel, including Jeff Boivin, that the pens are only scraped during the winter months, and that the manure in the pens is left to accumulate during summer,⁷⁶ where the moisture in the manure is susceptible to leaching through the ground.

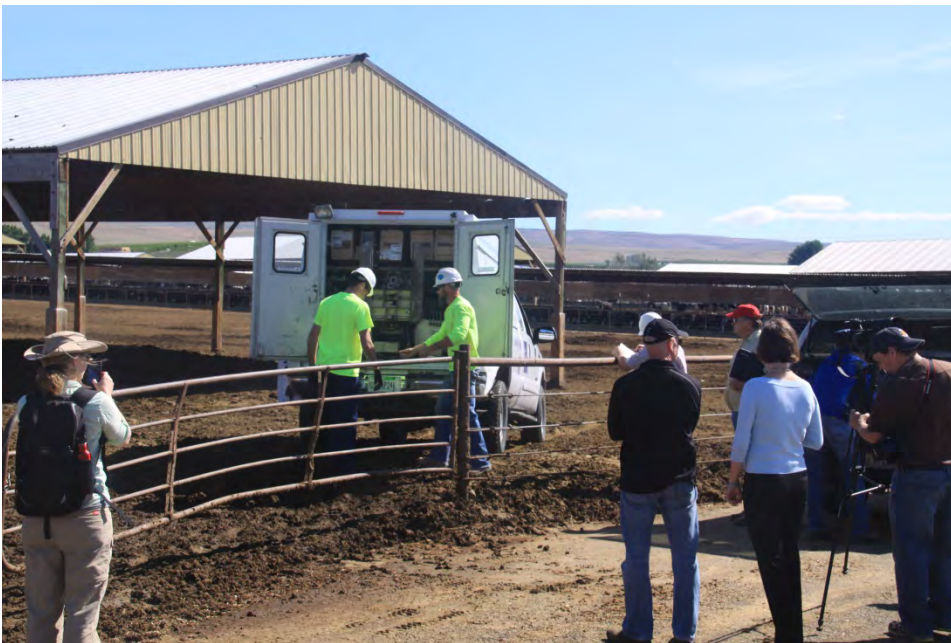
Photo. Geoprobe boring in the Cow Palace Pens.

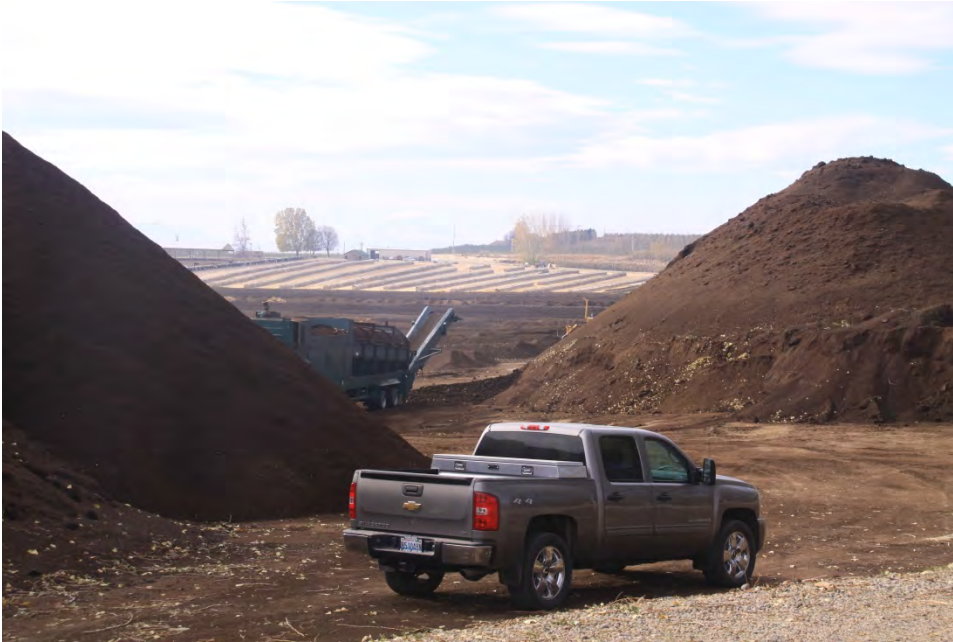
Photo. Cow Palace compost processing area.

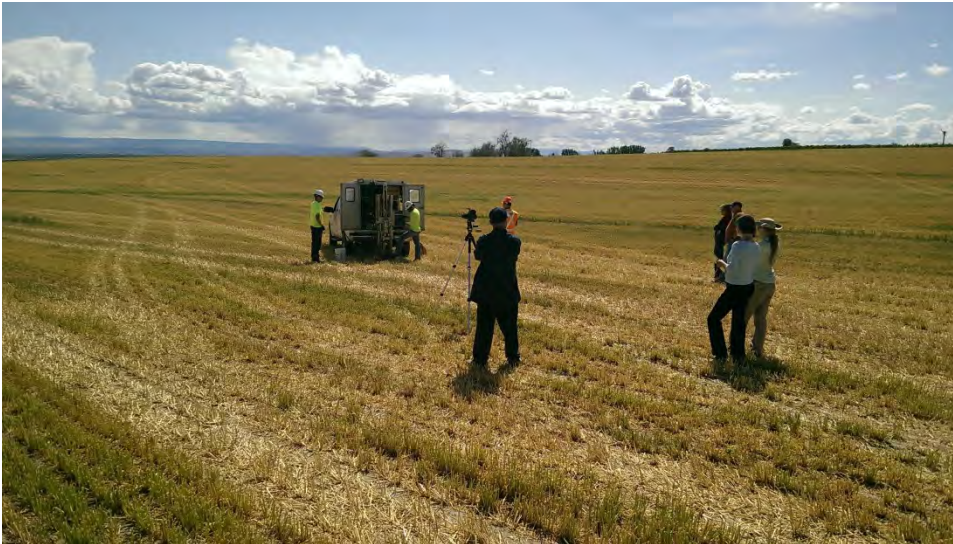
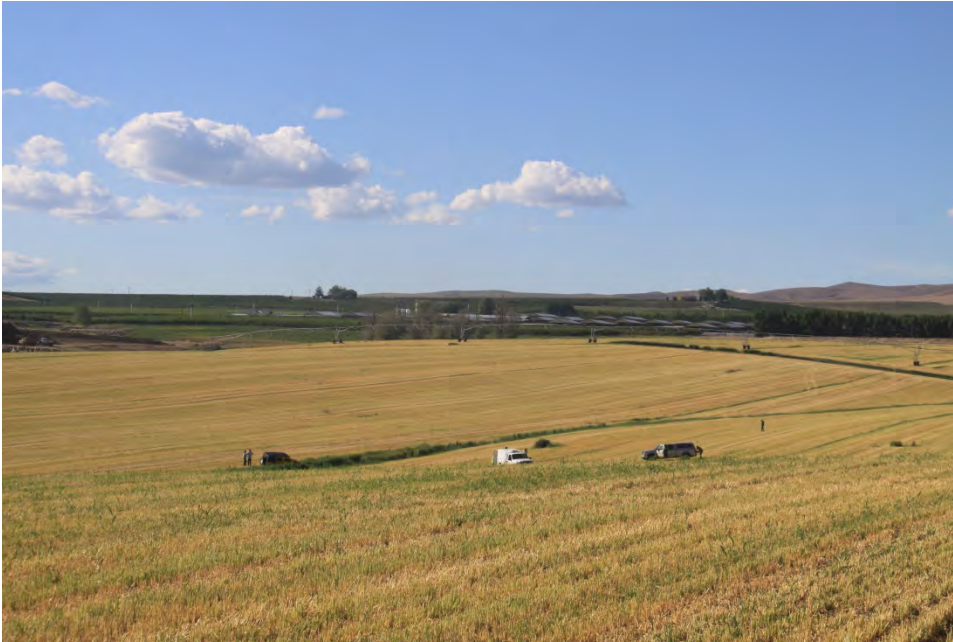
135. Significant sources of nitrate loading to groundwater come from Cow Palace's crop fields. I personally observed the collection of 36 composite soil samples using Geoprobe hydraulic direct-push drill rigs. The samples were collected at approximately 1-foot depth intervals from the ground surface down to 5 feet bgs. The photographs below fairly depict the field areas I observed in May 2014.

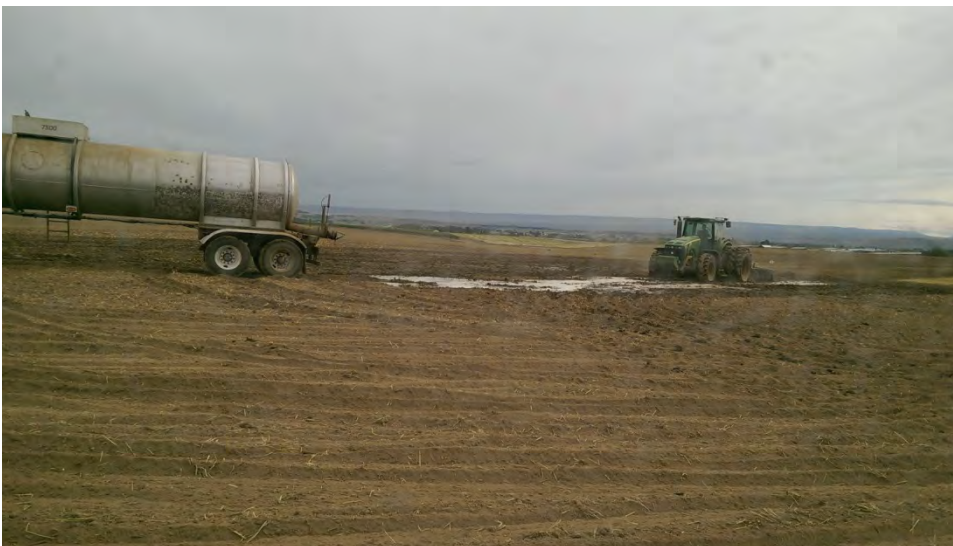
Photo. Liquid manure application and tilling.
